Photograph Log for EPA's December 9, 2010 Owens-Brockway Glass Container RCRA Inspection

On December 9, 2010, a hazardous waste compliance inspection was conducted by representatives of the United States Environmental Protection Agency ("EPA"), accompanied by a representative from the Oakland Fire Department at Owens-Brockway Glass Container Inc., located in Oakland, CA with EPA Identification Number CAT000618918. During the course of this investigation, information was gathered in accordance with Section 3007(a) of the Resource Conservation and Recovery Act ("RCRA"), as amended {42 U.S.C. §6927(a)}.

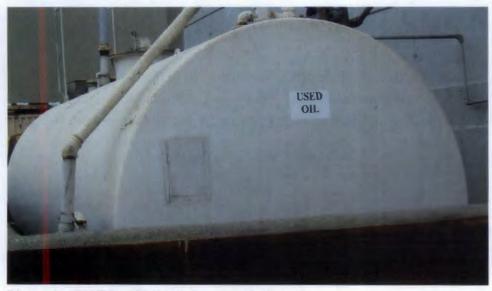
Photo 2: "USED OIL" label on used oil tank

The inspectors noted a 3950-gallon used oil tank located outside of the facility's main building (used oil is a non-RCRA, California only hazardous waste). Although the tank had a hazardous waste label, the label had faded to the point that it was essentially unreadable (Photo 1). The tank was clearly marked with the words "Used Oil", per regulatory requirements (Photo 2).

- Ensure that all hazardous waste containers identified in the accompanying report as improperly labeled, be labeled with the following information:
 - the words "Hazardous Waste";
 - the initial date of waste accumulation;
 - composition and physical state of the waste:

Ensure that all hazardous waste tanks identified in the accompanying report as improperly labeled, be labeled with the following information:

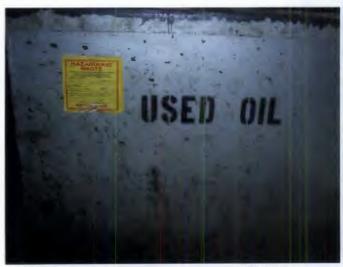
Photo 8: used oil tank

2025-gallon above-ground used oil tanks. The two tanks are located on a concrete floor which appeared to be in good condition (i.e., showed no signs of cracks). The tanks are elevated approximately three inches above the concrete floor on one end and had adequate containment. Both tanks were properly marked with the words "USED OIL" and had hazardous waste labels (Photo 8). However, in both cases, the printing on the label had faded to the point where it was barely legible (Photo 9). As with the previously described used oil tank, no written logs were kept of daily inspections. In addition, the facility representative was not able to produce an engineer's certification of the tanks' structural integrity.

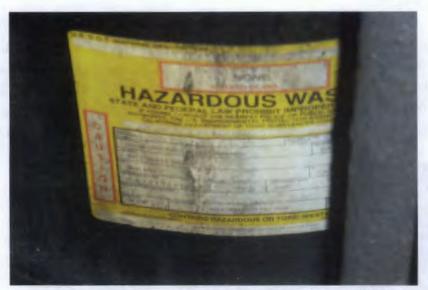
Photo 12: satellite accumulation container of used oil with unreadable label

- Adjacent to the spent blasting grit bin was a satellite accumulation area with a 55-gallon drum of used oil. The drum was labeled but the label was unreadable (Photo 12).

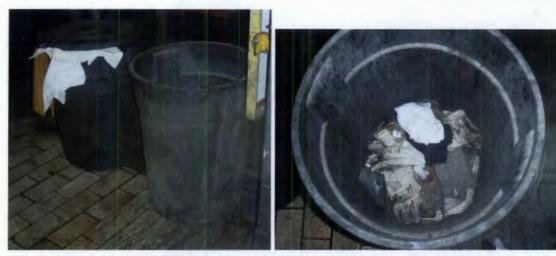
Photo 15: two open unlabeled drums Photo 16: interior shot of the second drum containing discarded PPE

- An unlabeled, open 55-gallon container of discarded PPE (gloves, coveralls, etc.) that appeared to be contaminated with grease or oil (Photo 15). Adjacent to this container was an unlabeled, open drum containing a mixture of trash and contaminated PPE (Photo 16). The facility representative was not able to verify at the time whether or not the contaminated PPE in both containers was a non-RCRA, California only hazardous waste.

- Perform a hazardous waste determination on oil/grease contaminated rags and personal protective equipment (PPE). Provide EPA with the results of this determination. If it is determined that these wastes are hazardous, establish a Standard Operating Procedure (SOP) for all facility personnel to discard future such wastes correctly;

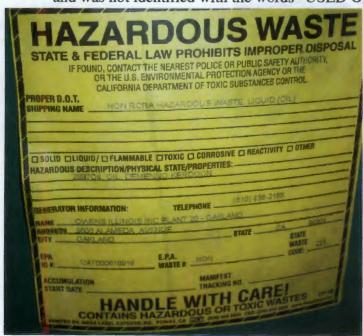
Photo 19: used oil container label without accumulation start date

- One 55-gallon drum of used oil whose label did not include an accumulation start date and was not identified with the words "USED OIL" (Photo 19);

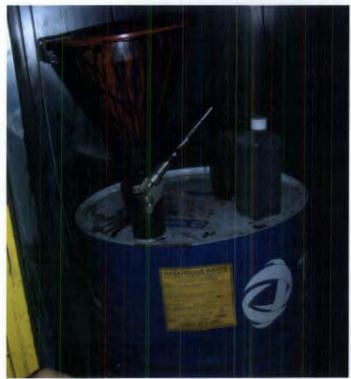
Photo 20: Drum of spent MEK with unlabeled quart bottle of MEK on top

- One 55-gallon drum of spent MEK. Although the drum was closed and labeled correctly, there was an unlabeled quart container of spent MEK on top of the drum (Photo 20).

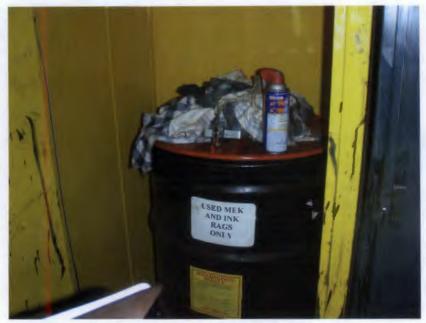
Photo 22: 55-gallon drum of used MEK with a pile of dirty rags and a spent aerosol on top.

One 55-gallon drum of rags with MEK ink. The drum was closed and labeled, but its accumulation start date was entered as 12/5/2005 (Photo 21) (the facility representative said that this was an incorrect date). In addition there was a pile of dirty rags and a spent aerosol can on top of the drum (Photo 22).

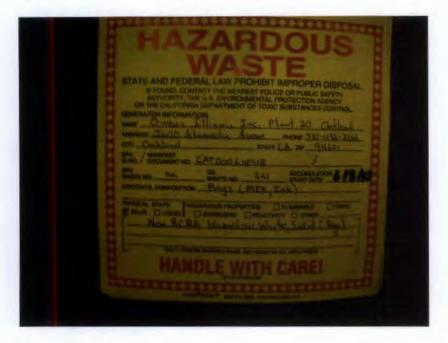
Also, a 55 gallon drum of discarded MEK contaminated rags had an incorrect date. This next photo shows the correction.

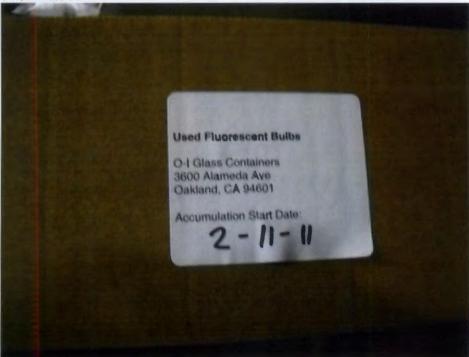
This next photo shows the spent fluorescent bulbs properly labeled with a start date of accumulation.

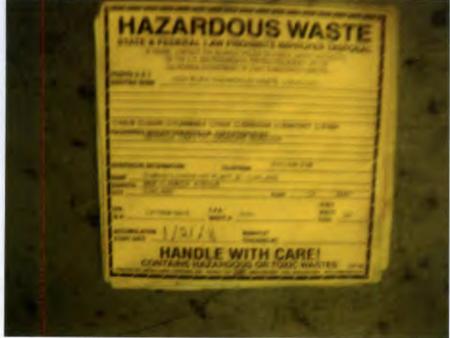
This photo shows the label of the used oil tank in the basement of C furnace area being legible.

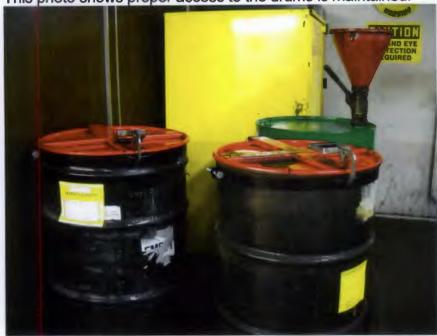
This photo shows proper access to the drums is maintained.

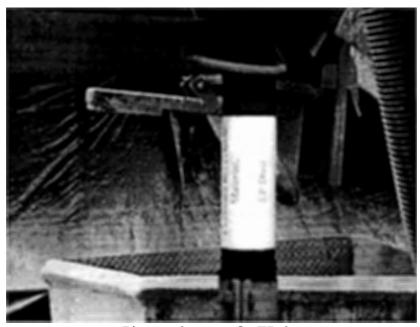
Pipe used to transfer EP dust

EP dust is raw material used to manufacture glass that is collected in the electrostatic precipitator and transferred automatically via pipe to a silo in the batch house where it is mixed into the batch.

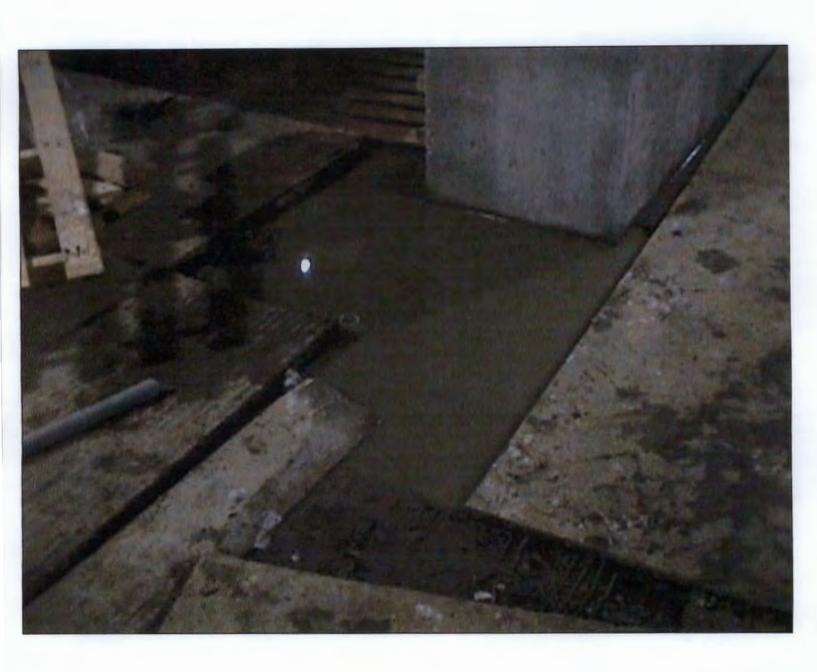
Area were green liquid was found.

(Green liquid on basement floor was cooling tower water with dye in it to find leak)
